# Case Series

## Case Study No. 1: Bunion Deformity

### Acumed® Biotrak® Helical Nail

## Case Study No. 2: Hammertoe Deformity

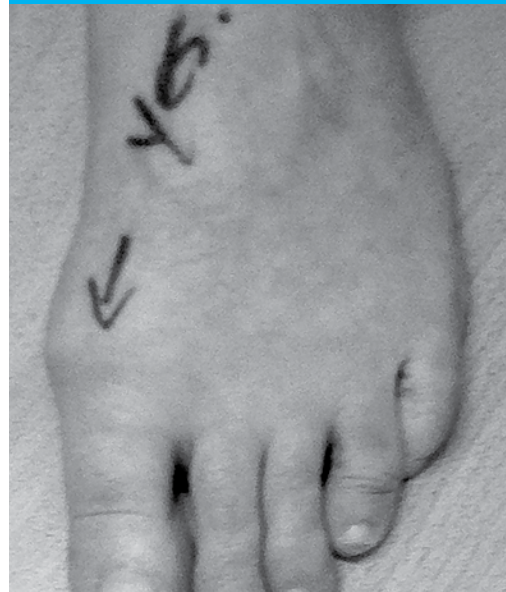
**Figure 1:** Preoperative appearance of the foot.

On physical examination, the hallux is abducted and the distal end of the metatarsal head is prominent. While the second toe is slightly elevated, she notes no symptoms referable to this digit. She is tender on the medial first metatarsal head prominence and the area is reddened and swollen. Radiographs of the foot show a hallux valgus deformity with mild lateral subluxation of the proximal phalanx on the metatarsal head with a prominent medial eminence.

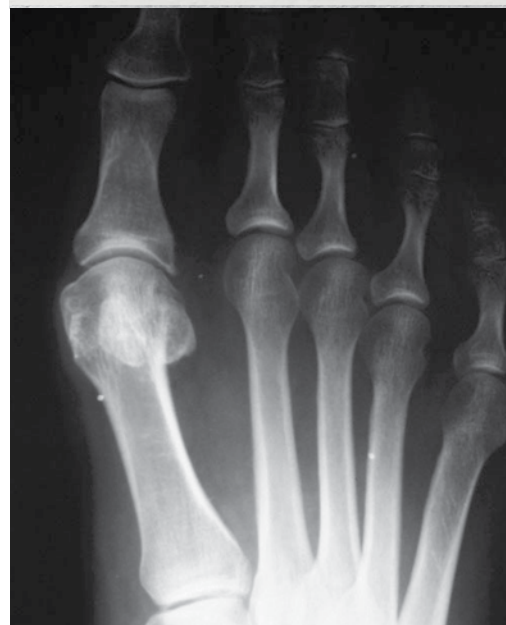
**Figure 2:** Preoperative radiograph of the foot.

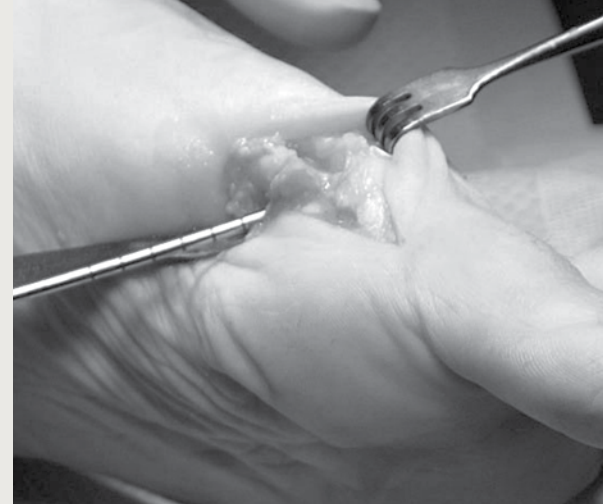
**Figure 3:** Intraoperative picture of the pin and reamer. The pin is inserted from the plantar surface.

A chevron osteotomy was made with an extended dorsal limb. The metatarsal head was translated laterally. The inferior metatarsal shaft was exposed and the metatarsal head translated laterally approximately 7 mm. The osteotomy was stabilized initially with a 0.9 mm Helical Nail guide wire. After confirmation fluoroscopically of optimal placement of the pin, this was measured and reamed. The osteotomy was stabilized with a tenaculum and an appropriate length Helical Nail was used to definitively stabilize the osteotomy.

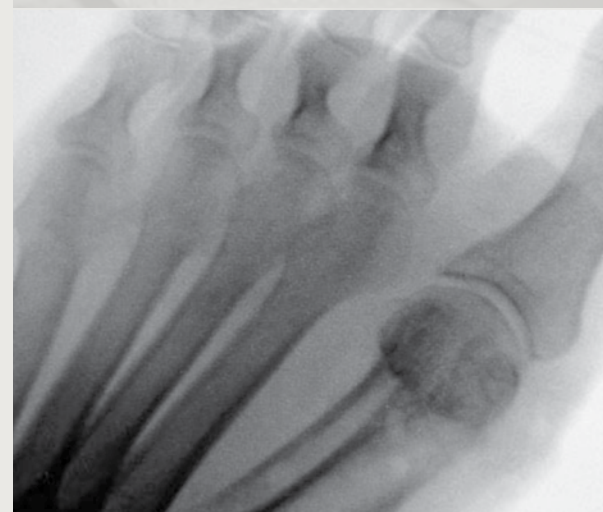
**Figure 4:** Postoperative radiograph of the foot after chevron bunionectomy.

A portion of excess dorsal Helical Nail was removed by cutting it from the leading edge of the implant. Shortening of the nail is intended to reduce the potential for it to back out.

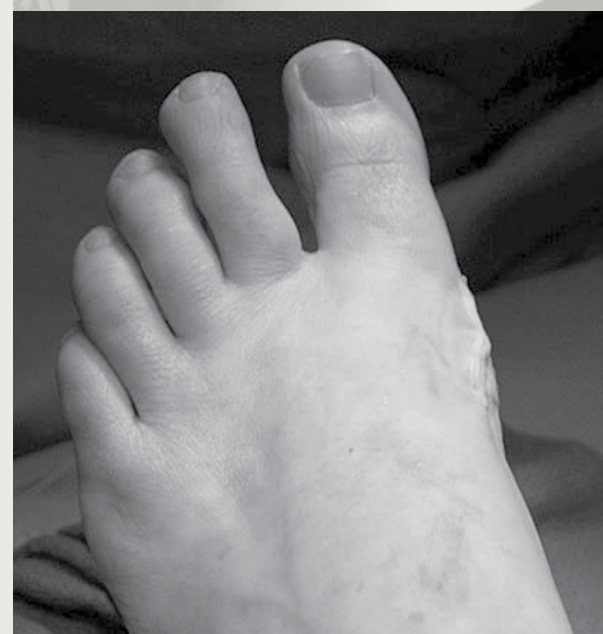
**Figure 5:** Postoperative picture of the foot after surgery. Excellent correction of the toe has been obtained.

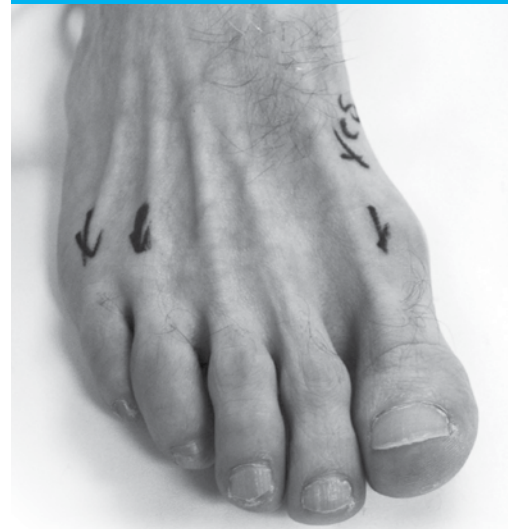
**Figure 1:** Preoperative appearance with overlapping of third and fourth toes on adjacent lateral toes.

The patient is a 53-year-old male who has a long history of discomfort to the right fourth and fifth toes. When standing, the patient's fourth toe lies under the third and the fifth toe lies under the fourth. He finds this to be significantly uncomfortable. He has experienced this for 2 years and has attempted to use toe separators and tape to reposition the toes without satisfaction. Incidentally, he also has a flexion deformity of the hallux interphalangeal joint which impinges on the upper of his shoe despite accommodative shoe wear.

On physical examination, the lesser toe deformity is accentuated by dorsiflexion of the ankle, but does not completely reduce with plantar flexion, indicating tightness of the flexor digitorum longus (FDL) muscle with secondary ligamentous contracture of the interphalangeal joints. Radiographs of the foot show no bony abnormality.

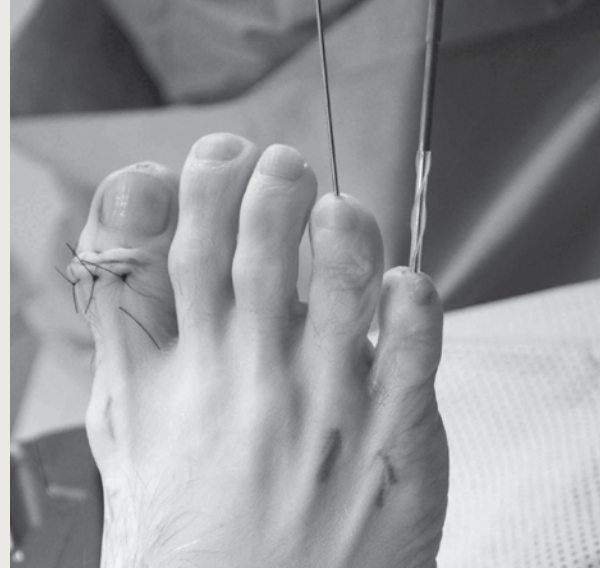
**Figure 3:** The Biotrak® Helical Nail is impacted into the toe.

Under fluoroscopic visualization, a guide wire was drilled from the distal phalanx into the base of the proximal phalanx. After confirming appropriate central and interosseous position of the pin, the skin was released around the pin with a stab incision. The length of the pin was measured with the depth gauge. The guide pin was over-reamed with the drill and the Helical Nail was impacted into the toe, countersinking the head of the Helical Nail into the distal phalanx.

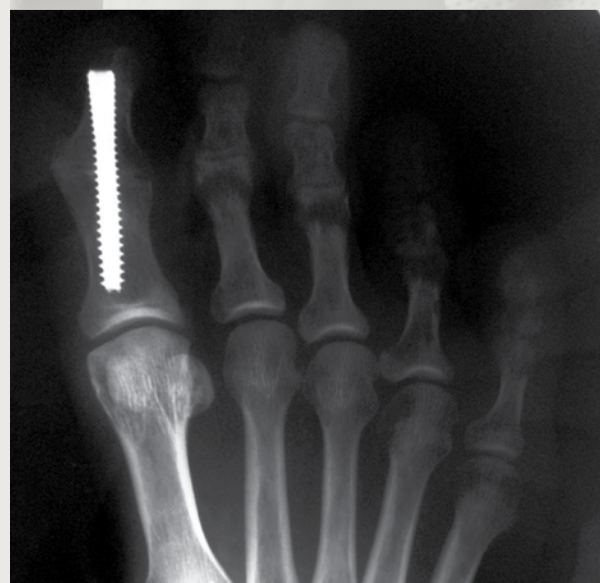
**Figure 4:** Radiographic view of the foot at 6 weeks.

**Postoperative Note:** Figure 4: In addition to the Hammertoe procedures done on the fourth and fifth metatarsals, a DIP fusion was performed on the first metatarsal using an Acutrak 2®.

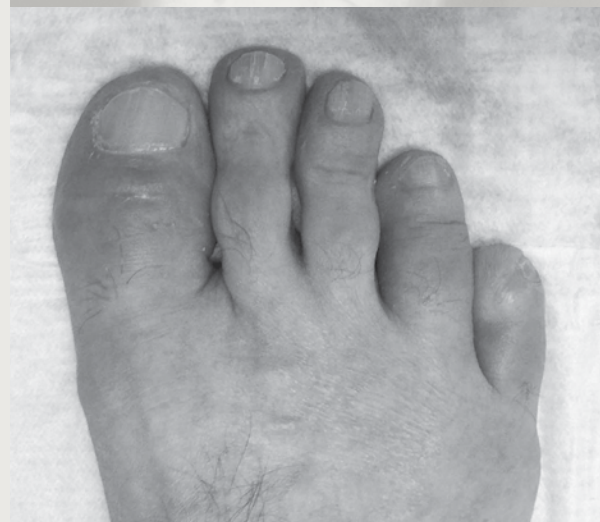
**Figure 5:** Clinical appearance of the foot at 6 weeks. No further malalignment of the toes is noted by the patient.

Postoperatively, the patient is allowed full weight bearing as tolerated. The toe remains stiff for six to twelve weeks. Usually, at that time, the structural integrity of the pin is lost and some mobility of the toe returns. Assuming that adequate release of the flexor tendons and contracted ligaments was achieved, recurrence of the deformity is rare although the toe remains somewhat stiff. This patient was satisfied that his toes no longer overlapped and noted considerable relief.
